Technical Evaluation of the Gold King Mine Incident

San Juan County, Colorado

U.S. Department of the Interior
Bureau of Reclamation
Technical Service Center
Denver, Colorado

October 2015

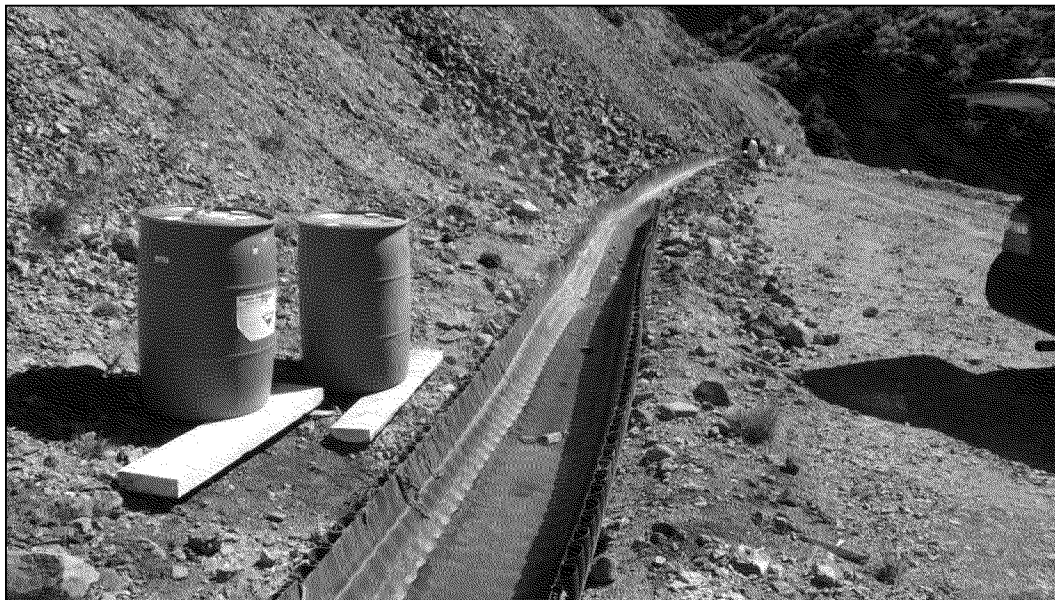
Figure 24.—Photograph showing seepage flow in the half-pipe channel at the Gold King Mine Level 7 New Adit area on September 11, 2014. Flow of approximately 12.6 gpm was recorded (photograph from EPA project files).

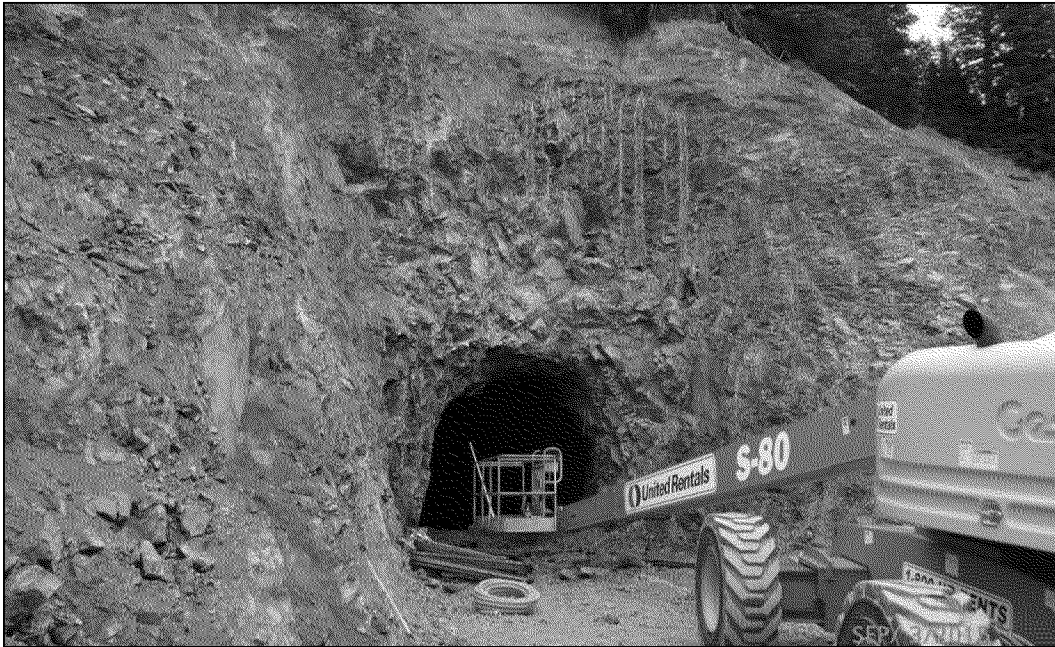
Figure 64.—Photograph showing the adit on September 3, 2015, at the initiation of rock bolting. The rock had been excavated to provide a larger work area. Note the excavator teeth marks left in the rock, an indication that the rock is altered and contains a significant amount of clay.
